Last Modified: 05-04-2021	6.10:8.0.50	Doc ID: RM100000001NUH0
Model Year Start: 2021	Model: Sienna HV	Prod Date Range: [11/2020 -]
Title: SEAT: REAR NO. 2 SEAT ASSEMBLY (for 60/40 Split Seat Type RH Side): REMOVAL; 2021 MY Sienna HV [11/2020 -]

REMOVAL

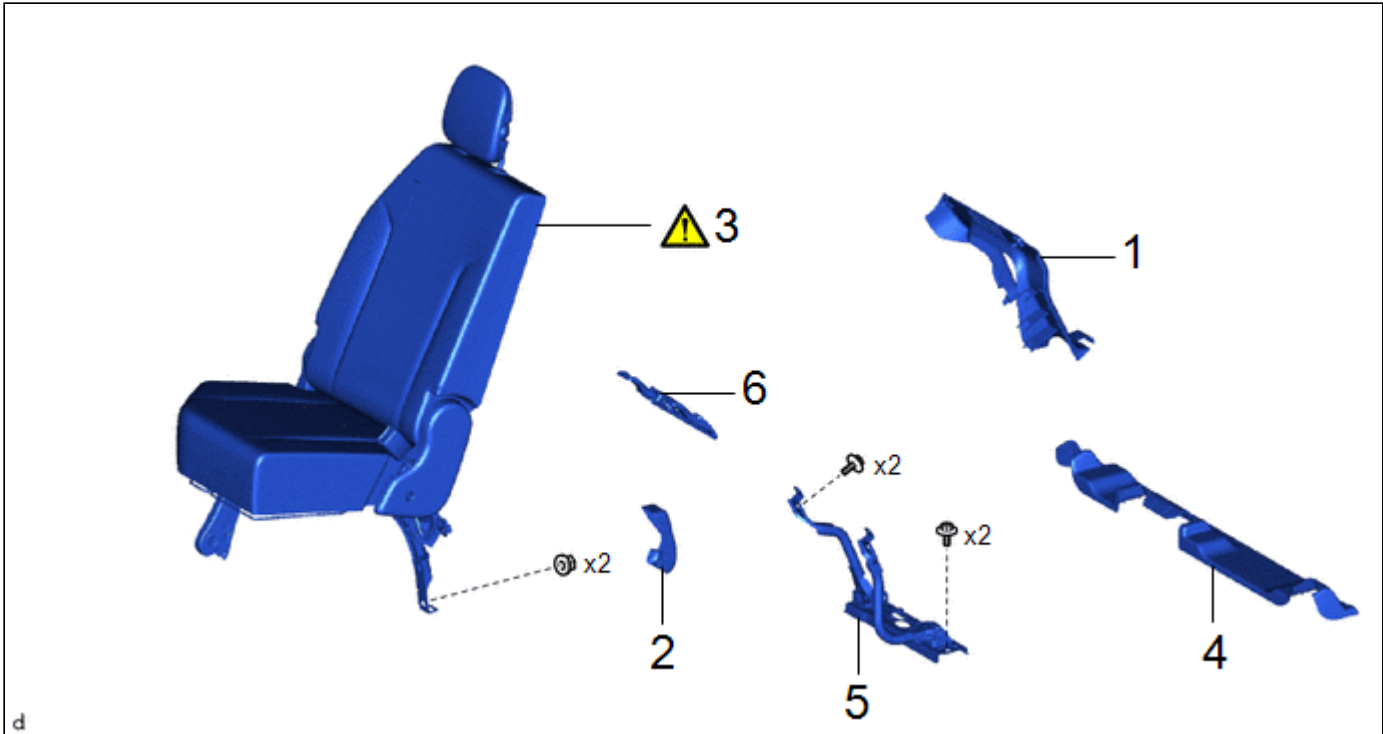
COMPONENTS (REMOVAL)

1	REAR SEAT LEG SIDE GARNISH SUB-ASSEMBLY RH	79091E	-	-	-
2	REAR NO. 2 SEAT HINGE COVER RH	79273D	-	-	-
3	REAR NO. 2 SEAT ASSEMBLY RH	-	-	-	-
4	REAR NO. 2 SEAT LEG SIDE GARNISH SUB-ASSEMBLY	79092C	-	-	-
5	FOLD REAR SEAT LEG SUB-ASSEMBLY RH	79806C	-	-	-
6	NO. 1 SEAT LEG BOX PROTECTOR	79997A	-	-	-

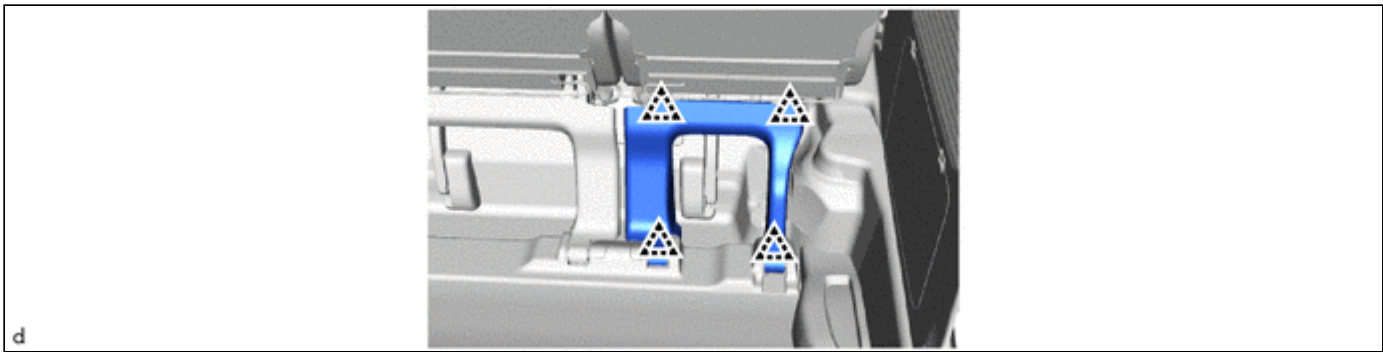
1. REMOVE REAR SEAT LEG SIDE GARNISH SUB-ASSEMBLY RH

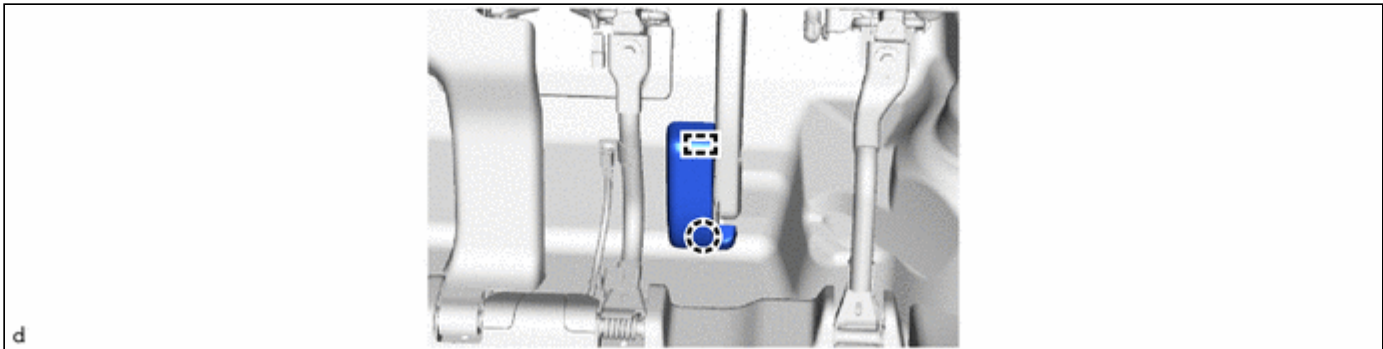
2. REMOVE REAR NO. 2 SEAT HINGE COVER RH

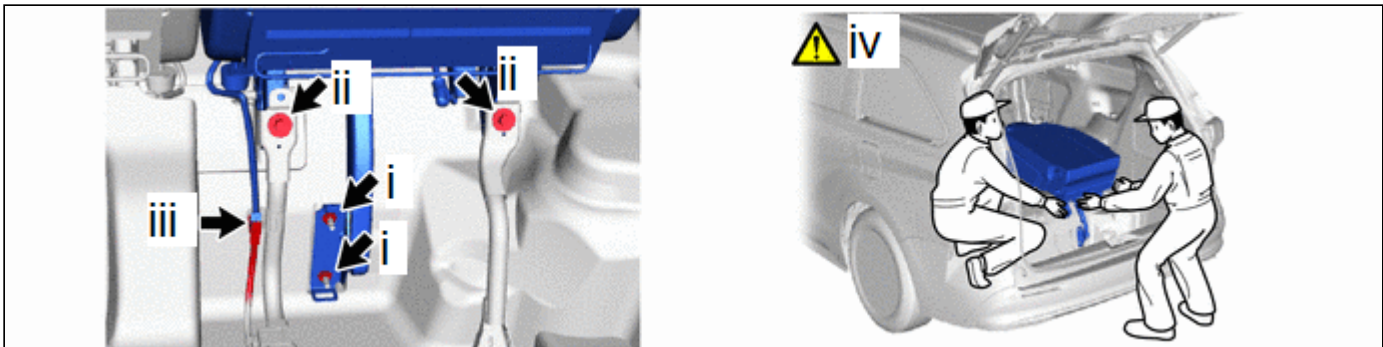
3. REMOVE REAR NO. 2 SEAT ASSEMBLY RH

- (1) Remove the 2 nuts.
- (2) Remove the 2 bolts.
- (3) Disconnect the connector.
- (4) Remove the rear No. 2 seat assembly RH.

- 2 or more people are required when carrying the rear No. 2 seat assembly RH out of the vehicle.
- Be careful not to damage the vehicle body.

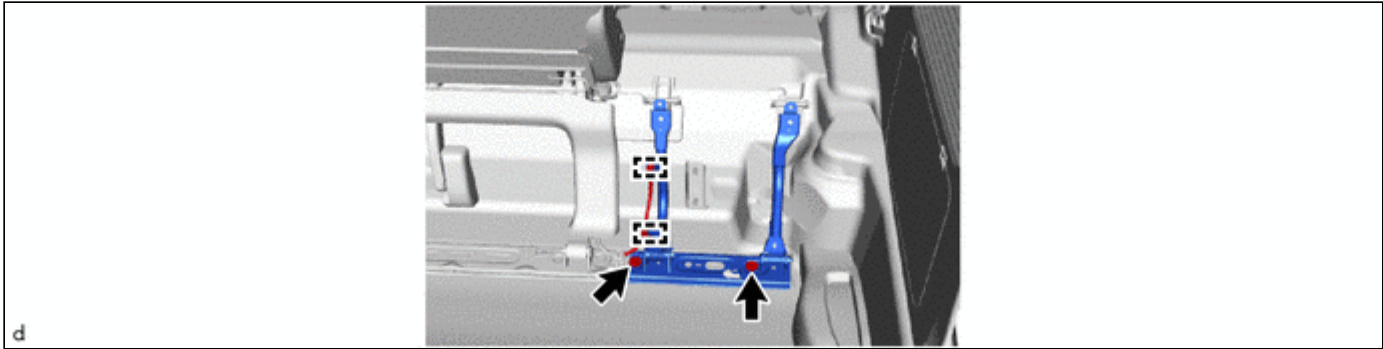
5. REMOVE FOLD REAR SEAT LEG SUB-ASSEMBLY RH
