Last Modified: 12-09-2020	6.10:8.0.50	Doc ID: RM100000001NUDU
Model Year Start: 2021	Model: Sienna HV	Prod Date Range: [11/2020 -]
Title: SEAT: REAR NO. 1 SEAT ASSEMBLY (for Captain Seat Type): REMOVAL; 2021 MY Sienna HV [11/2020 -]

REMOVAL

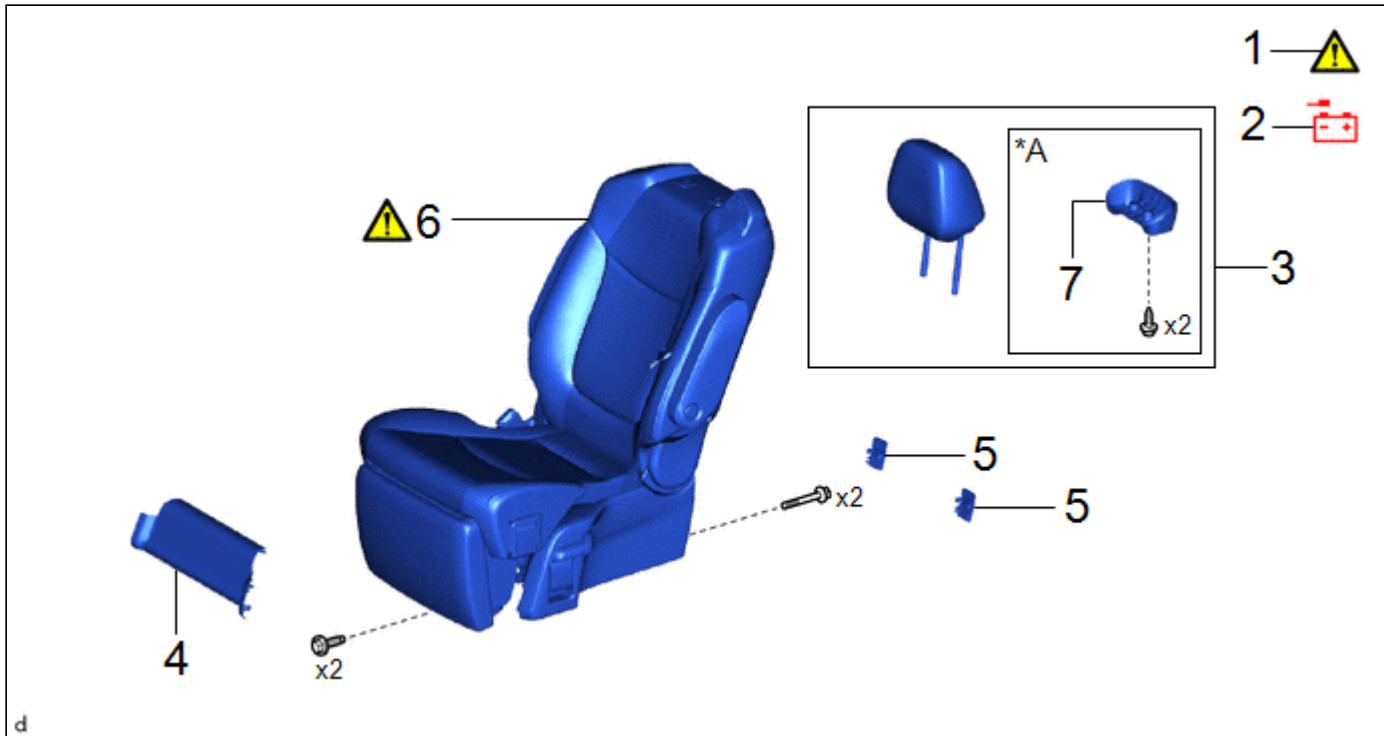
COMPONENTS (REMOVAL)

PROCEDURE		PART NAME CODE			
1	PRECAUTION	-		-	-
2	DISCONNECT CABLE FROM NEGATIVE AUXILIARY BATTERY TERMINAL	-	-	-	-
3	NO. 1 SEAT HEADREST ASSEMBLY	71940G	-	-	-
4	REAR SEAT CUSHION LOWER SHIELD	71874X	-	-	-
5	REAR SEAT CUSHION LOWER SHIELD LH	71H74	-	-	-
6	REAR NO. 1 SEAT ASSEMBLY	-		-	-
7	REAR SEAT HEADREST UNDER COVER	71952B	-	-	-

*A	w/ Headrest Bezel	-	-
----	-------------------	---	---

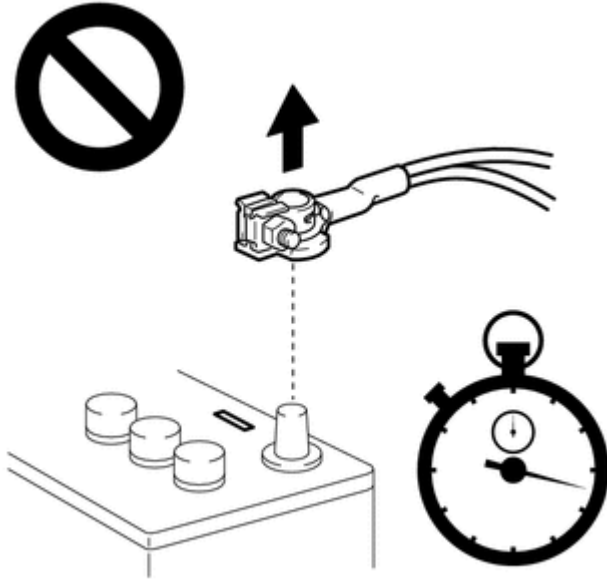
2. DISCONNECT CABLE FROM NEGATIVE AUXILIARY BATTERY TERMINAL

Wait at least 60 seconds after disconnecting the cable from the negative (-) auxiliary battery terminal to disable the SRS system.

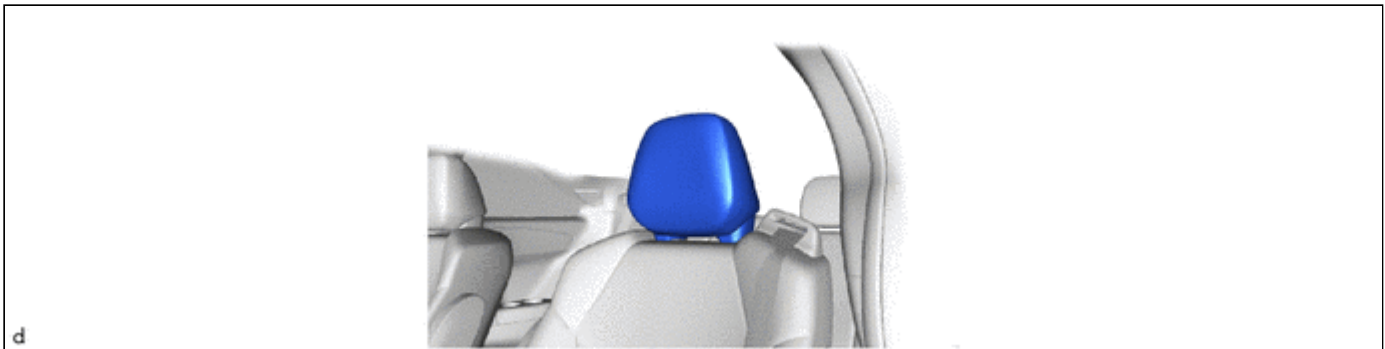
3. REMOVE NO. 1 SEAT HEADREST ASSEMBLY

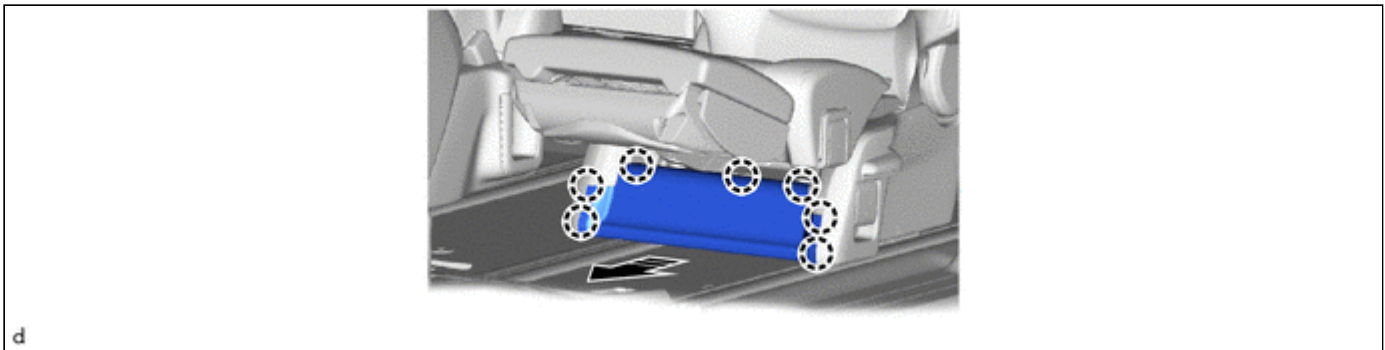
4. REMOVE REAR SEAT CUSHION LOWER SHIELD

Remove in this Direction

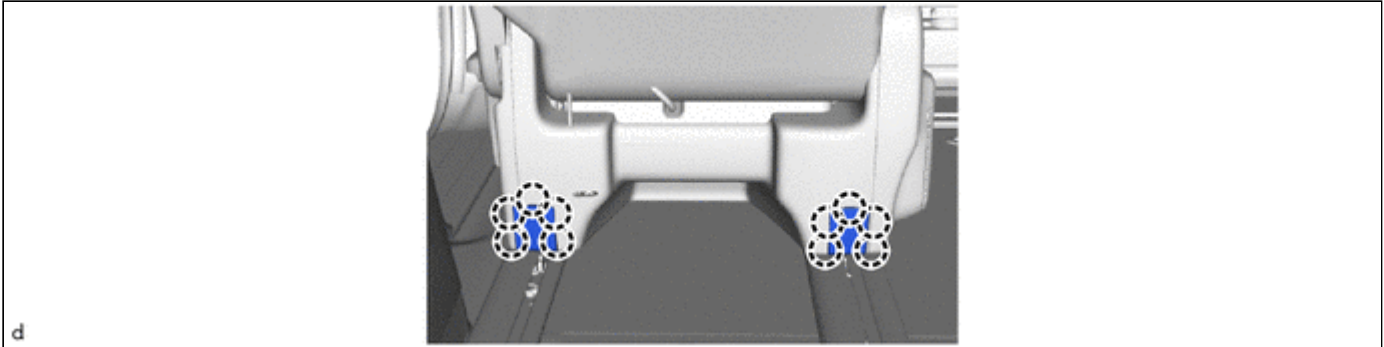
5. REMOVE REAR SEAT CUSHION LOWER SHIELD LH

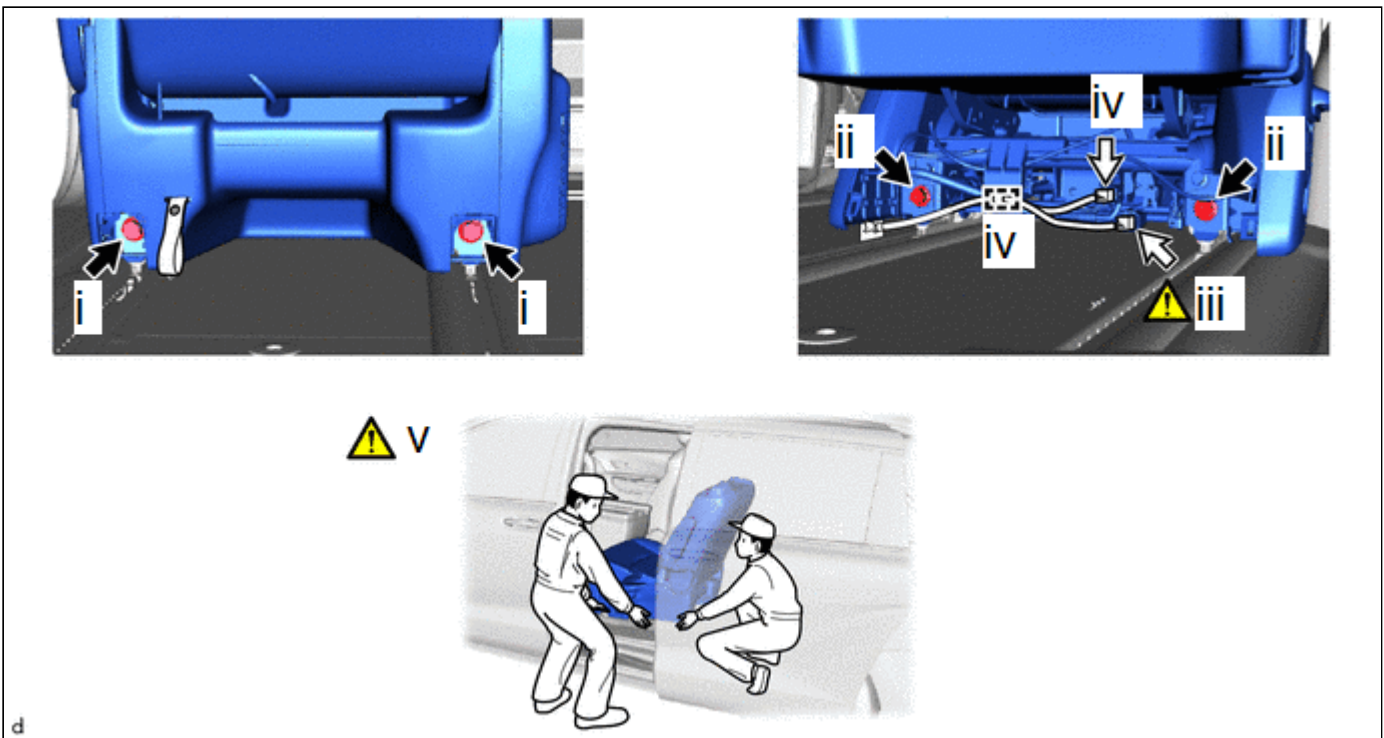
6. REMOVE REAR NO. 1 SEAT ASSEMBLY

- (1) Remove the 2 bolts on the rear side of the rear No. 1 seat assembly.
- (2) Remove the 2 bolts on the front side of the rear No. 1 seat assembly.
- (3) Disconnect the front seat airbag assembly connector under the rear No. 1 seat assembly.

- (4) Disconnect the connector and disengage the clamp.
- (5) Remove the rear No. 1 seat assembly.

When disconnecting any airbag connector, take care not to damage the airbag wire harness.

- 2 or more people are required when carrying the rear No. 1 seat assembly out of the vehicle.
- Be careful not to damage the vehicle body.

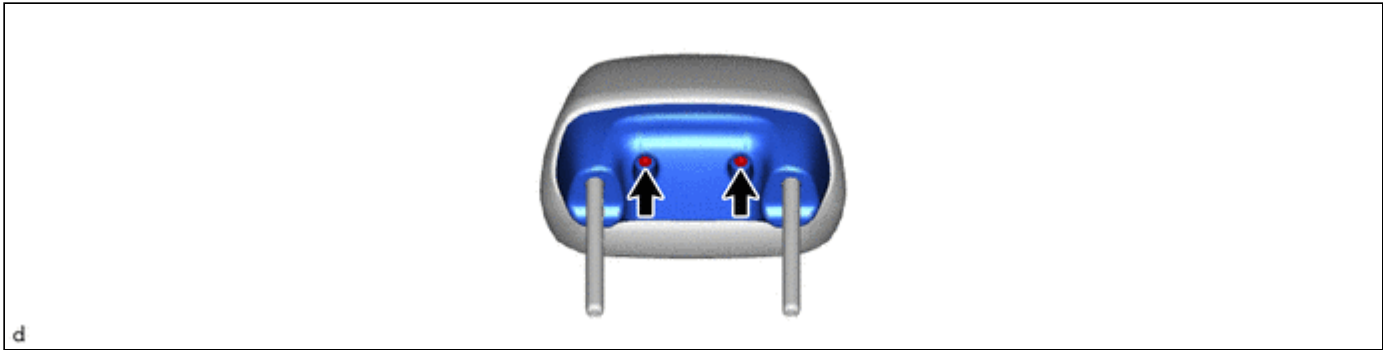
7. REMOVE REAR SEAT HEADREST UNDER COVER (w/ Headrest Bezel)

Perform this procedure only when replacement of the rear seat headrest under cover is necessary.
